# RAYTHEON STARSHIP

## Composite Wing & Fuselage Evaluation

# Quick Look Report

11 April, 2006

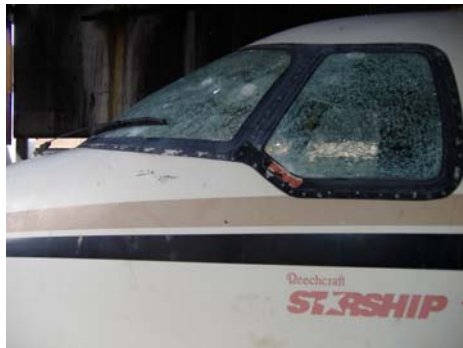
Fragment impacts and blast overpressure shattered windshields.

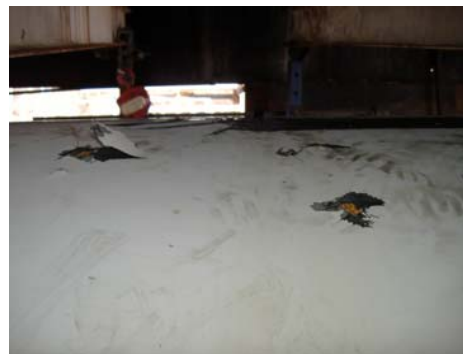
Nose cone and Base plate of round exit top of fuselage.

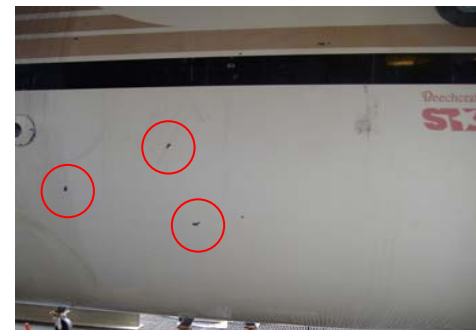
Fragments penetrate belly of aircraft.

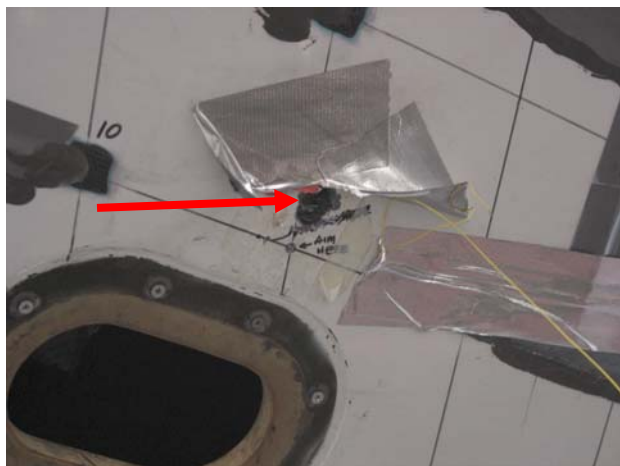
23mm HEI entrance hole.

Below wing looking up.

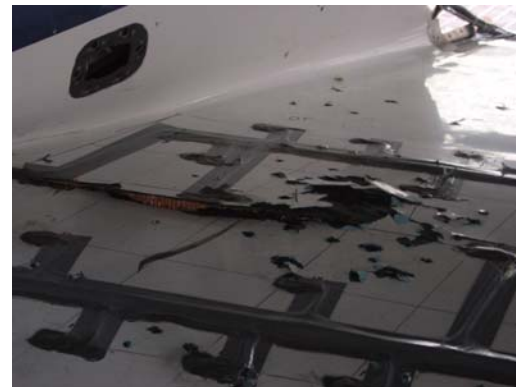
Exit pattern.  
Above wing  
looking aft.

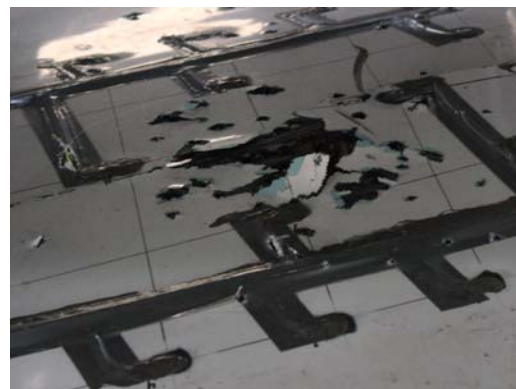
Exit pattern.  
Above wing  
looking  
forward.

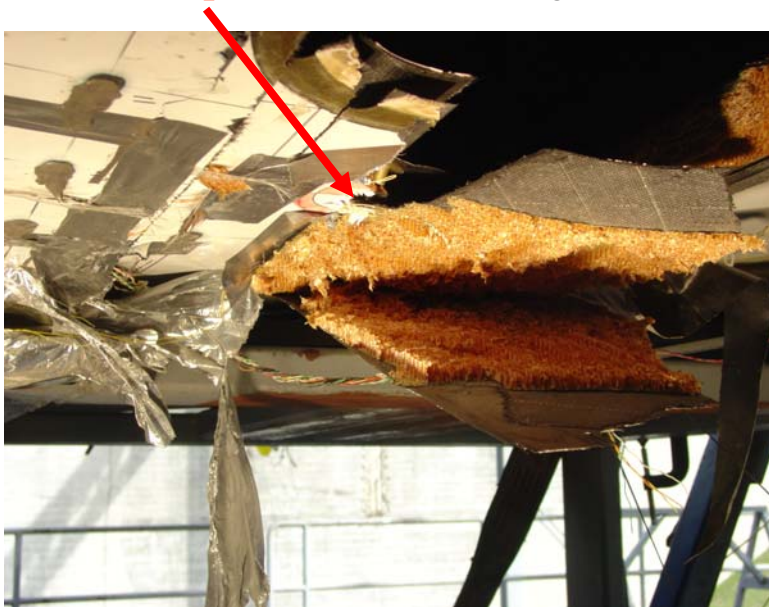
Threat entrance point and explosion exit area. (aim point) Below looking aft.

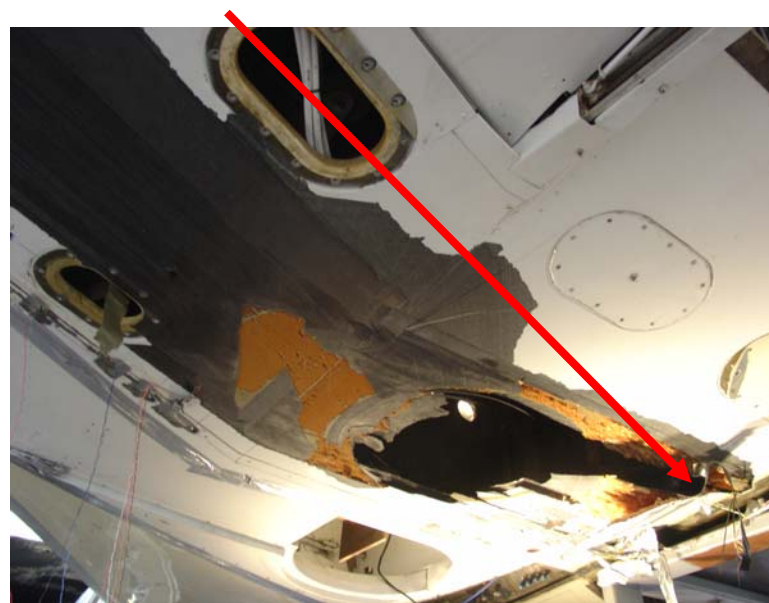
Threat entrance point and explosion exit area. (aim point) Below looking forward.

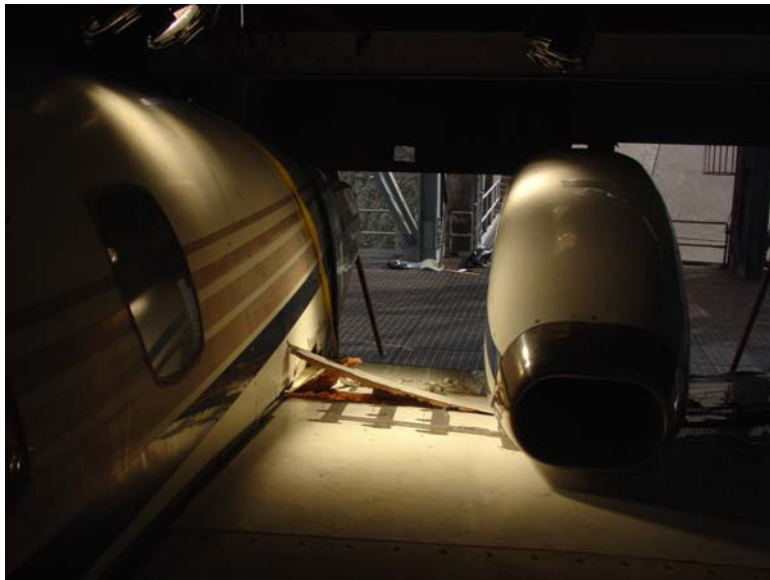
Exit area and hydrodynamic ram structural damage. Above looking aft.

- HEI threats will function upon impacting composite honeycomb structure. HEI functioning will result in overpressure and fragmentation damage to the surrounding structure. HEI hydrodynamic ram forces will massively damage composite structure surrounding a 80 gallon water filled fuel tank and bladder.

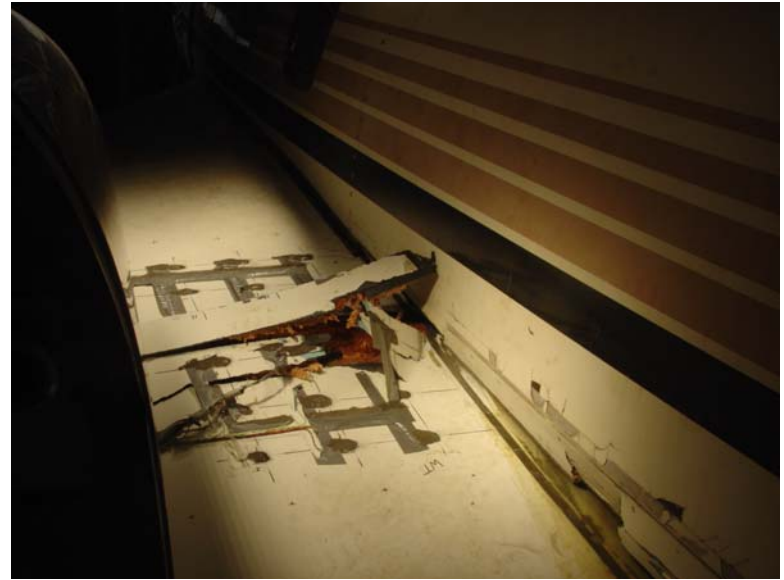
Exit area and hydrodynamic ram structural damage. Above looking forward.

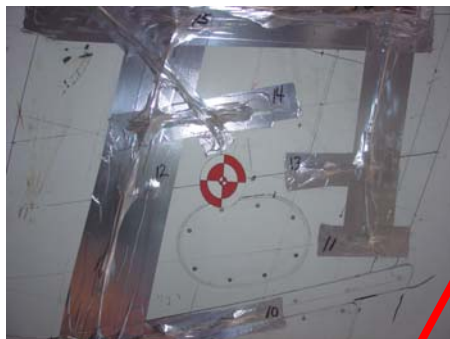
Instrumentation and entrance hole on bottom of wing.

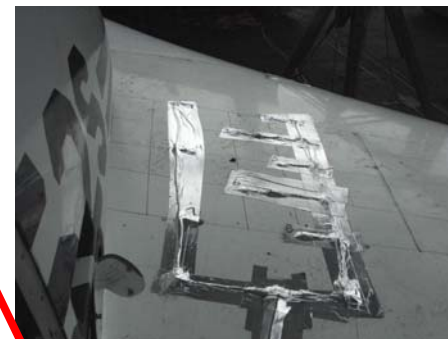
Instrumentation and exit hole on top of wing.

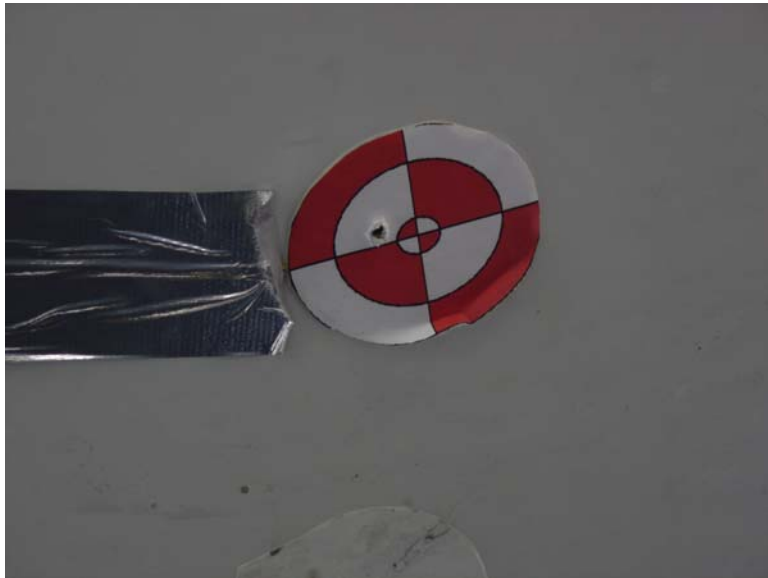
Entrance hole

- The projectile traveled approximately 25 feet from the gun to the test article's lower surface. The projectile penetrated the wing.

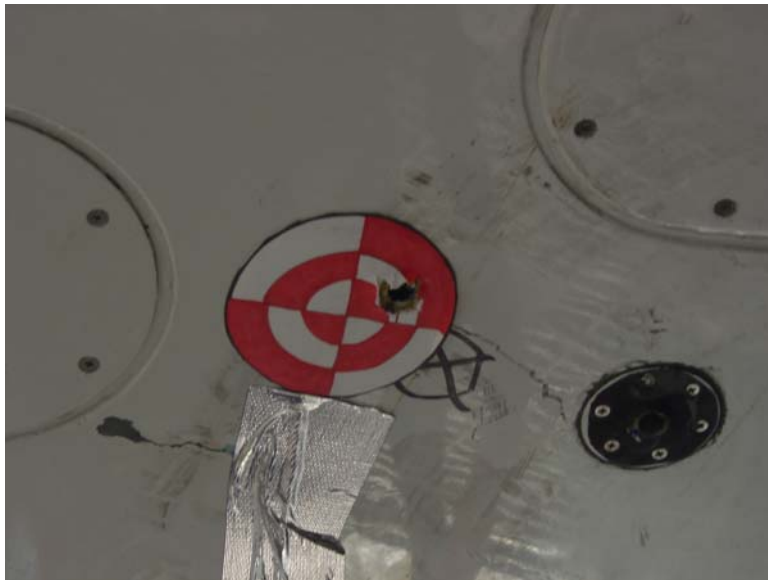
Threat entrance point.

(aim point) Below looking aft.

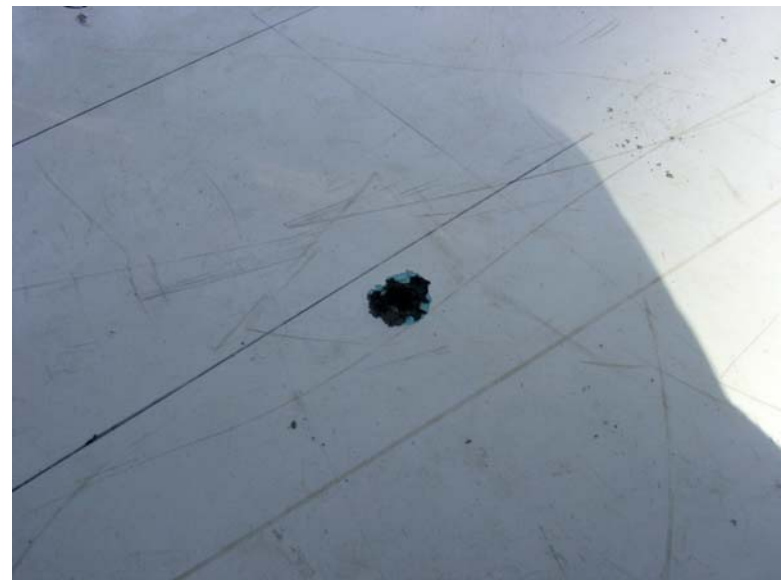
Threat exit point. (aim point)

Below looking forward.

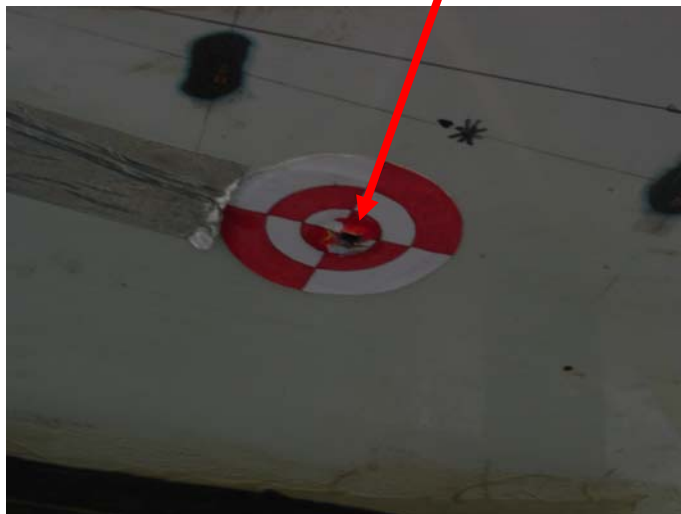
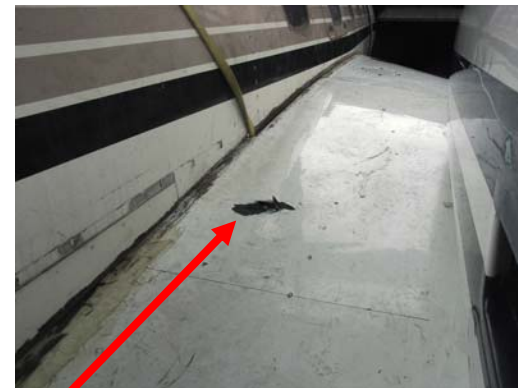
Threat entrance point. (aim point)

Below looking aft.

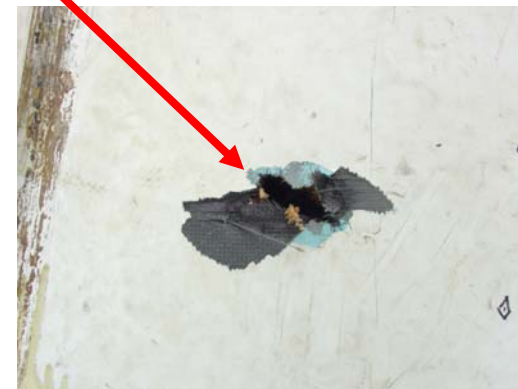
Threat exit area. (aim point) Above looking forward.
