# RAYTHEON STARSHIP

## Composite Wing & Fuselage Evaluation

# Quick Look Report

11 April, 2006

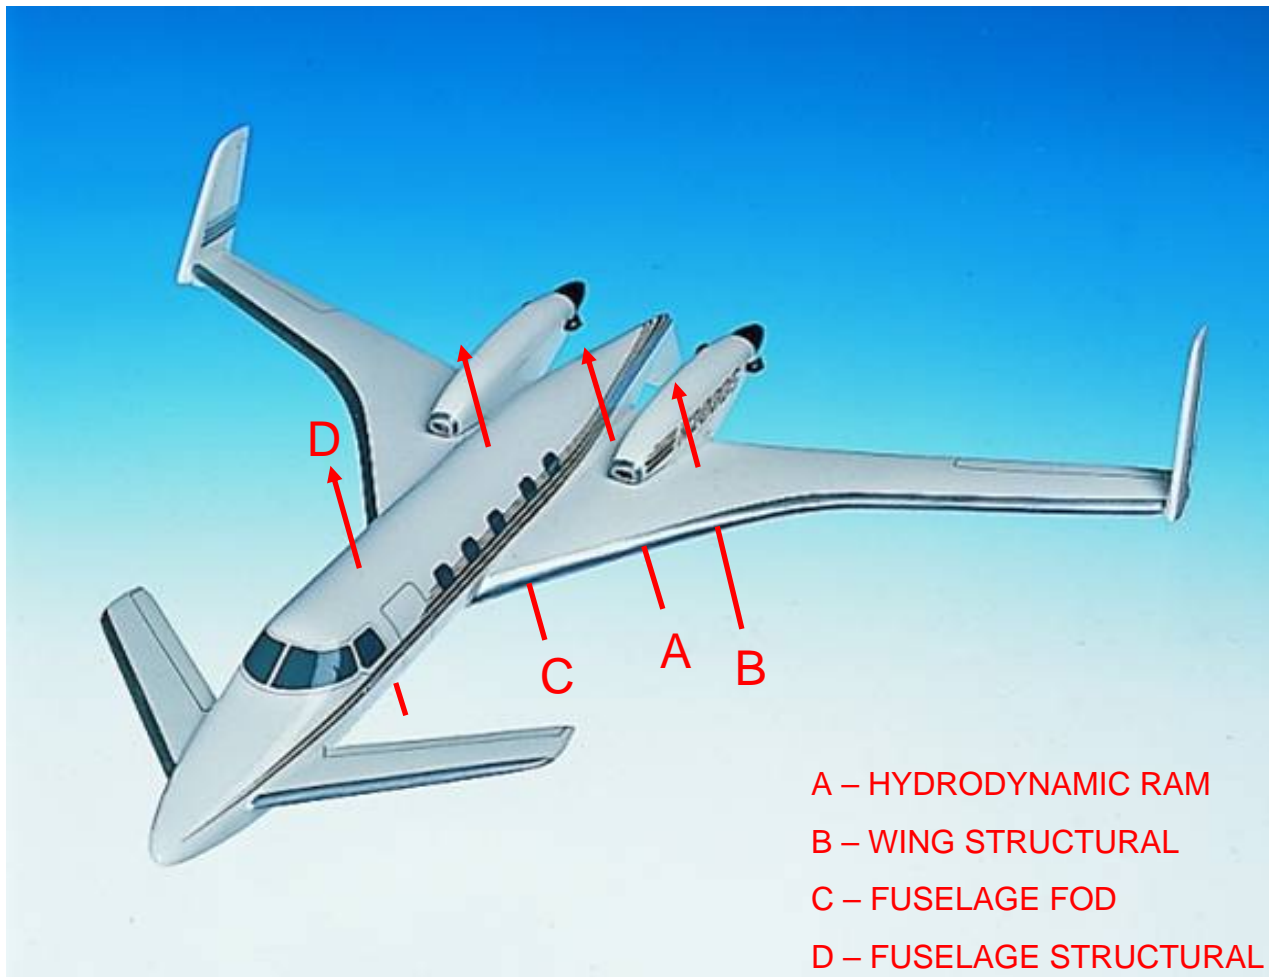
# Composite Wing & Fuselage Evaluation Shot Lines Phase I

Shot	Threat	Location	Airflow	Loading
1 (D)	23mm HEI	Fuselage Forward	Yes	Pressurization 8 psi
2 (C)	F.O.D.	Fuselage Aft	No	No
3 (B)	23mm HEI	R. Wing (dry) O.B. of E.N.	Yes	Pre 1.2g Test 1.0g Post 1.4g
4 (A)	23mm HEI	R. Wing (wet) I.B. of E. N.	Yes	Pre 1.2g Test 1.0g Post TBD

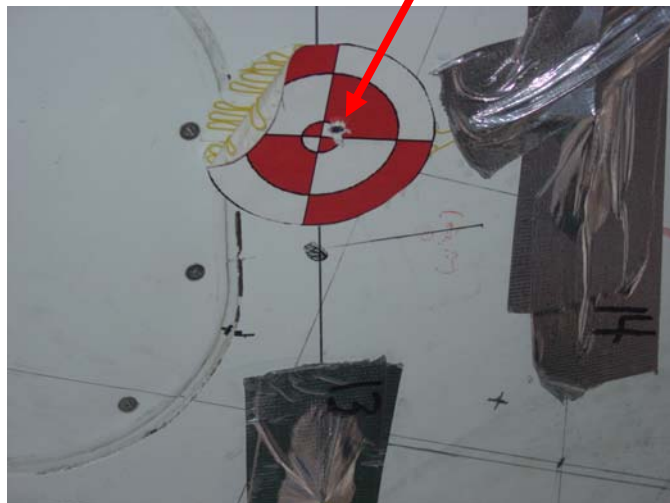
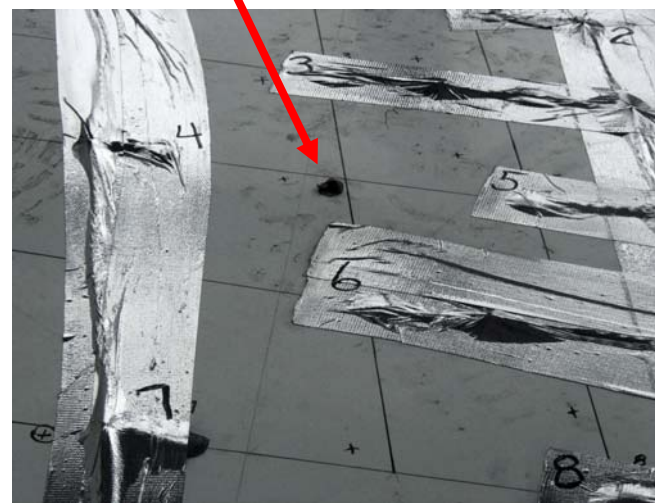
Instrumentation and exit hole on top of wing.
